# Monitoring Microstructural Evolution of Alloy 617 with Non-Linear Acoustics for Remaining Useful Life Prediction; Multiaxial Creep-Fatigue and Creep-Ratcheting

**Project Title:** Monitoring microstructural evolution of Alloy 617 with nonlinear acoustics for remaining useful life prediction; multiaxial creep-fatigue and creep-ratcheting 10-915

**Period:** January 1, 2010 through August 30, 2014

**Report Date:** October 30, 2014

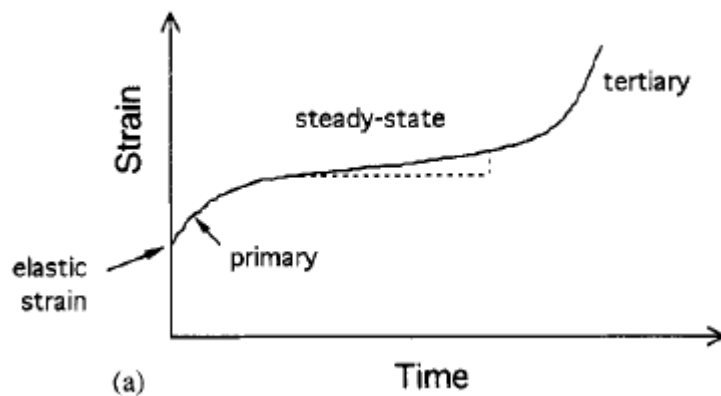
**Figure 2.1.2.1.** Typical creep curve, with three stages characterized by strain rate, taken from [2].

Uniaxial creep tests involve applying a constant load, where the resulting stress is lower than the yield strength. The plot of the measured engineering strain as a function of time can usually be divided into three states: primary (transient), secondary (steady state), and tertiary stages, based on the strain rate trends as seen in Figure 2.1.2.1. Within each stage, certain deformation mechanisms typically occur and eventually lead to void formation, necking and rupture.

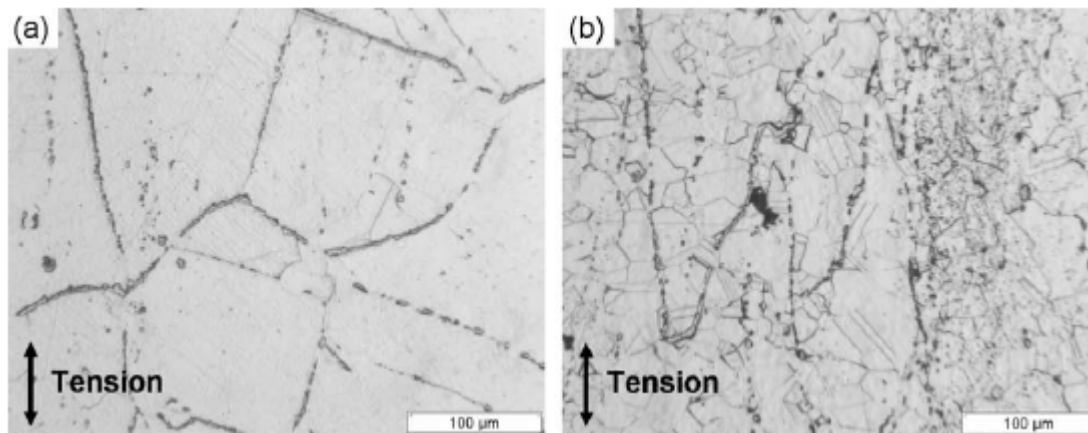
**Figure 2.1.2.2.** Crept sample of as received Alloy 617 after rupture at 950°C at test stress of MPa from Chomette et al [3]. Microstructure of sample taken: (a) far from rupture zone, which had low reduction in area, (b) near the rupture zone, which had high reduction in area.

The microstructures obtained in the experiments conducted for this report could also be compared to previous literature sources. Chomette et al [3] have conducted creep tests at stresses of 70 MPa at 850°C and 30MPa at 950°C, and analyzed the influence between aging, cold working of 20% and as received conditions provided by Special Metals, Inc. They have tested on cylindrical specimens with the gage length and gage diameter of 30 mm and 5 mm respectively for testing in air, while 25 mm and 6 mm were used in vacuum. They had gradually applied weights with a mean loading rate of approximately  $1.4\text{--}2\text{ N s}^{-1}$ , at test temperatures of 850°C and 950°C. With those experiments, they have observed some boundary migrations, recrystallization, and specific growth and location of carbides such as  $\text{M}_6\text{C}$ ,  $\text{Ti}(\text{C},\text{N})$ , and  $\text{M}_{23}\text{C}_6$  carbides depending on the specimen treatment and creep test temperature. In addition, Chomette et al [3] also compared the microstructure at two different locations relative to the rupture zone as shown in Figure 2.1.1.2. Thus, observed features depend on the selection of the sample area for optical microscopy or transmission electron microscopy (TEM).

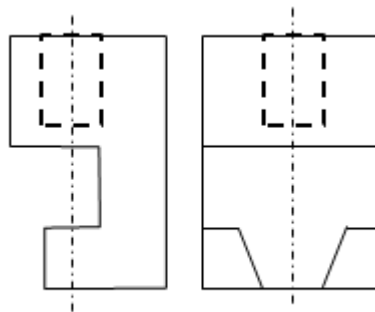
**Figure 2.1.2.4.** Side and front views of the fixture having horizontal bearing surfaces. The top of the fixture is drilled and tapped for a threaded rod.

The fixture shown in Figure 2.1.2.4 was used for creep tests until specimen C03 ruptured at a lower strain value than specimen C02 under the same temperature and load conditions. The setup was examined, a slight bend with the top fixture was noticed, which introduced a bending component to the

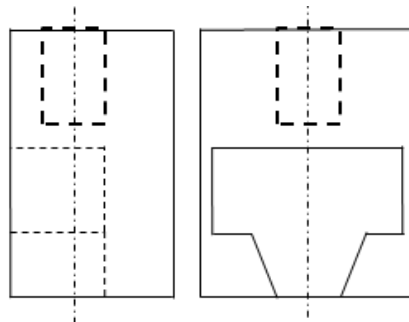
**Figure 2.1.2.5.** Stiffened top fixture design prevented bending.

loading, which most likely would have been more than 10% of the axial load. Additional experiments were conducted with a stiffened version of the fixture as shown in Figure 2.1.2.5. All experiments starting with specimen C04 used this fixture design.

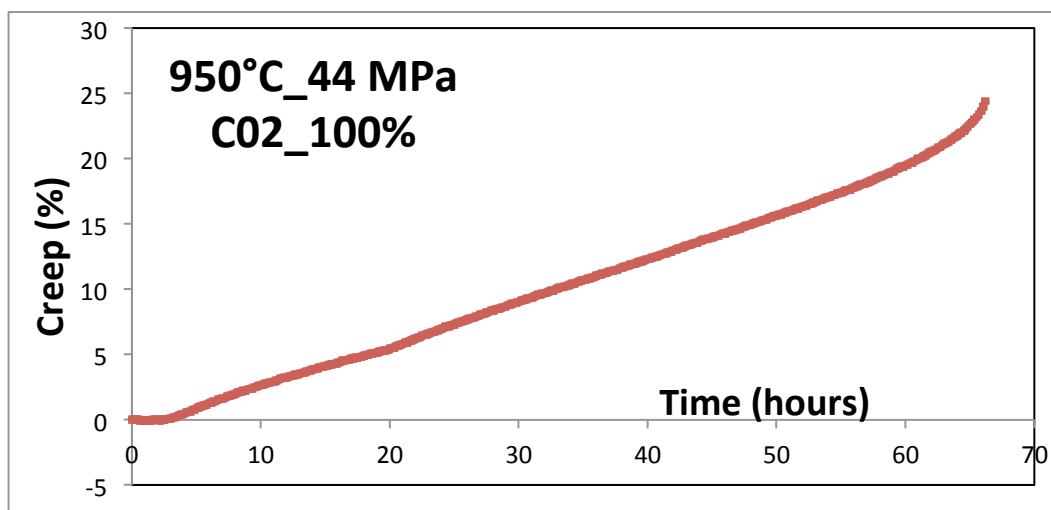
**Figure 2.1.2.7.** Engineering creep strain as a function of time for specimen C02 at 950°C under 44 MPa. The test ended in rupture at 24.4% strain.

There are two notable constant strain rates before tertiary creep occurred with Figure 2.1.2.7; a slightly faster creep rate starts after ~20 hours. Comparison with the temperature log and creep trends shows that the change in creep rate was due to a slightly higher temperature, and will be discussed in a latter section. After 66.2 hours the specimen ruptured at an elongation of 24.40% and true strain of 21.83%, computed by  $\ln(1+e)$ .

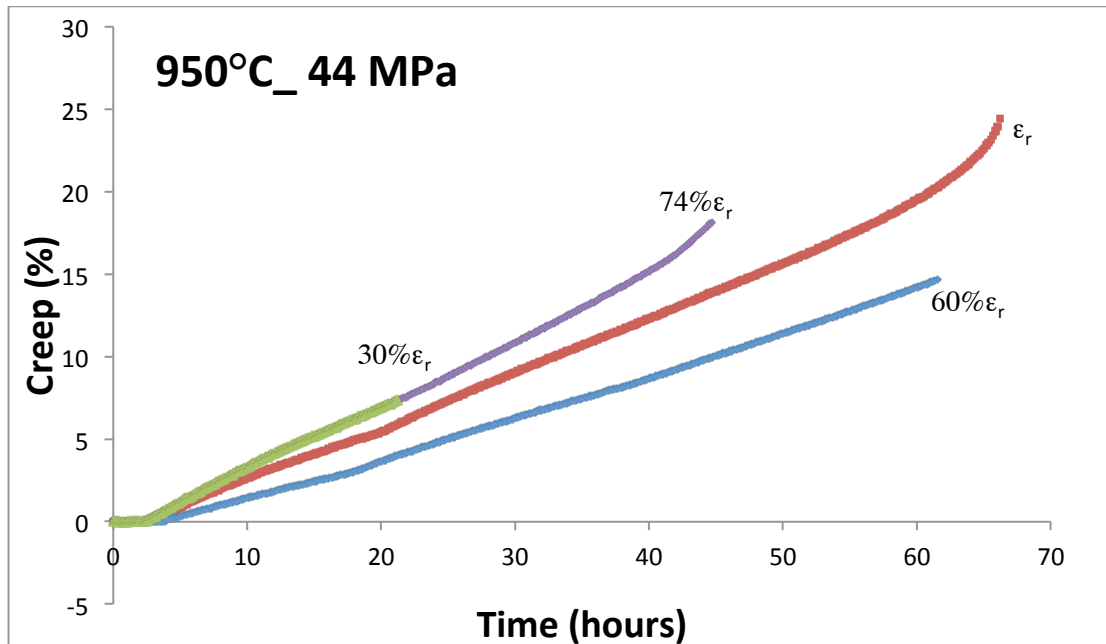
**Figure 2.1.2.8.** Engineering strain of the test set at 950°C and 44 MPa. Specimen C02 is the ruptured test, and the others are interrupted.

Other experiments were conducted at 950°C and with the same stress of 44 MPa, with some deviation from the creep curve. These additional tests were interrupted at strains of 7.32, 14.64, and 18.06% (i.e., 30, 60, and 74% of the rupture strain). The specimens interrupted at 30% and 74% of the rupture strain, have very similar creep rates and are slightly different from the other two specimens, which have slower creep rates as shown in Figure 2.1.2.8. It is likely that the different creep rates, which are computed in Table 2.1.2.4, are associated with presence of slightly different temperatures during the experiments.

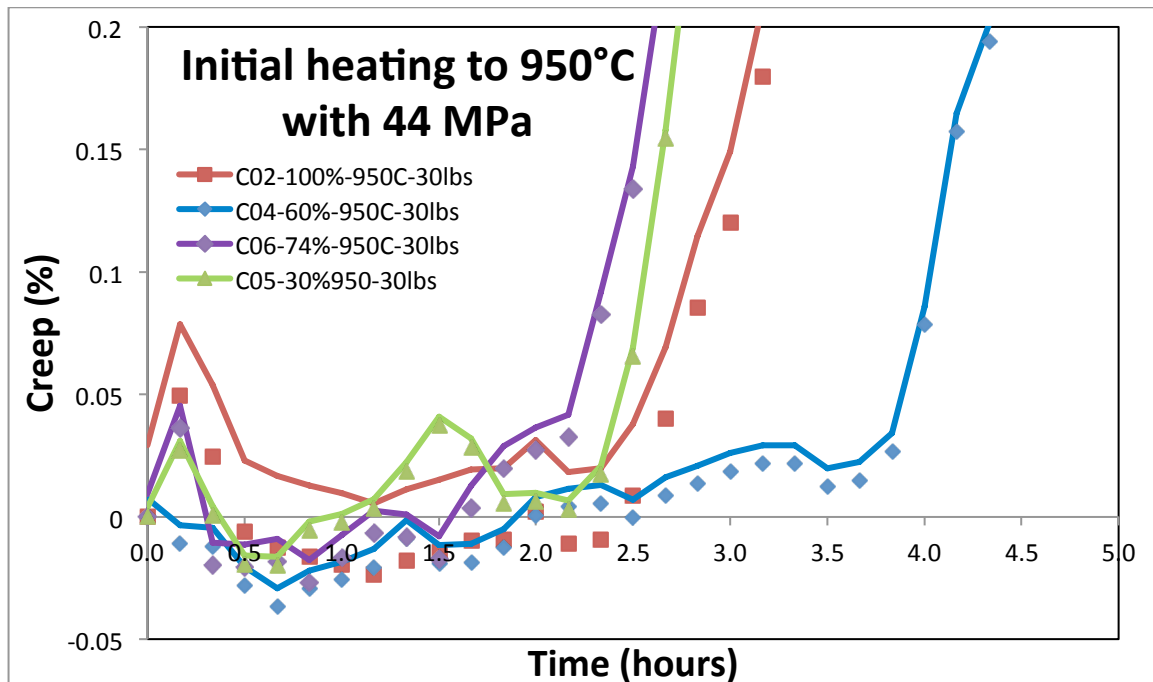
**Figure 2.1.2.9.** Initial strain during the heating from room temperature to about 950°C.

As shown in Table 2.1.2.5, the time required for the specimen to heat to approximately 950°C is variable. Figure 2.1.2.9 shows the initial strain versus time for the first 4.5 hrs of testing. There is a variability of up to 2 hrs in terms of when creep strain began to accumulate at a significant rate.

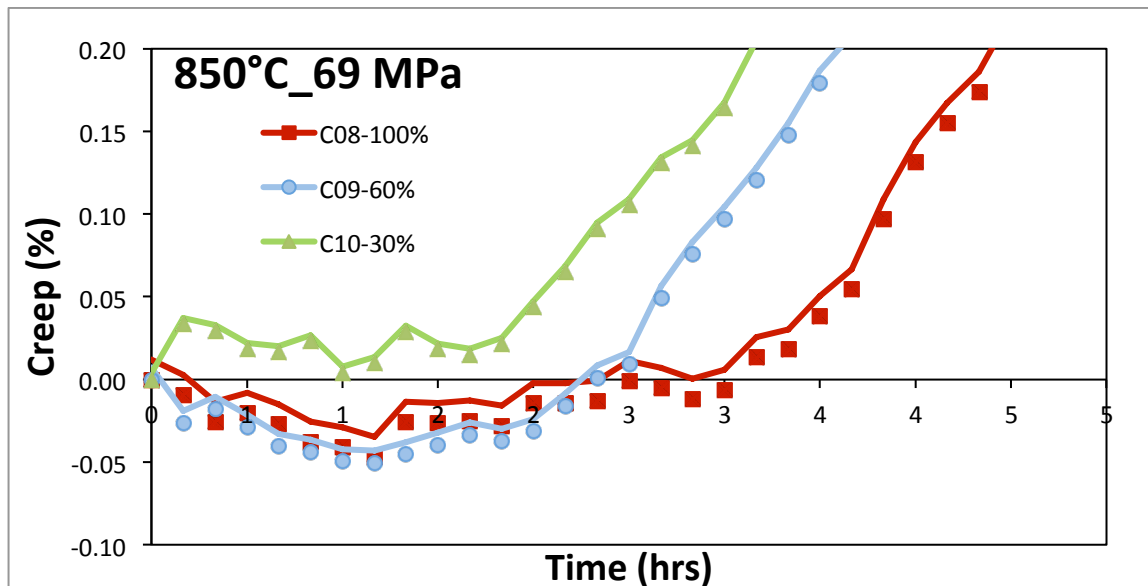
**Figure 2.1.2.10.** Strain during the initial heating from room temperature to approximately 850°C.

For test set 2 the test temperature as 850°C and the nominal stress is 69 MPa, about 34.7% of the yield strength (200 MPa). During the initial heating phase to 850°C given in Figure 2.1.2.10, there was also variation in strain accumulation akin to that shown in Figure 2.1.2.9. After 164.2 hours, specimen C08 ruptured at a nominal strain of 23.97 % (true strain of 21.49%).

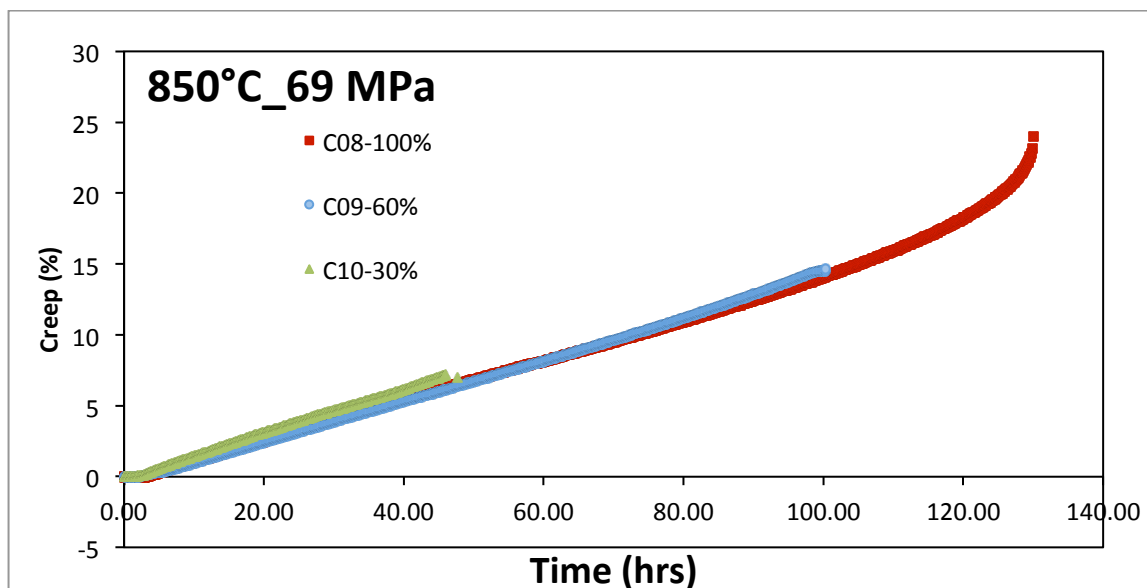
**Figure 2.1.2.11.** Creep strain as a function of time for test set 2, at 850°C and ~69 MPa. Specimen C08 crept to rupture, while Specimens C09 and C10 were interrupted.

The creep curves within this test set of 850°C and 69 MPa shown in Figure 2.1.2.11 are more consistent than those of the test set at 950°C and 44 MPa (Figure 2.1.2.8). For this test set, specimen C08 was crept until rupture. For this set of experiments, 850°C and 69 MPa, the HH506RA Multilogger thermometer was used to record the temperature reading from two locations. One thermocouple was spot welded to the center of the specimen's gage length (T1), and another connection was used to measure the ambient temperature of the furnace with its initial position about 10 mm from the specimen and slightly higher than the center of the specimen's gage length (T2).

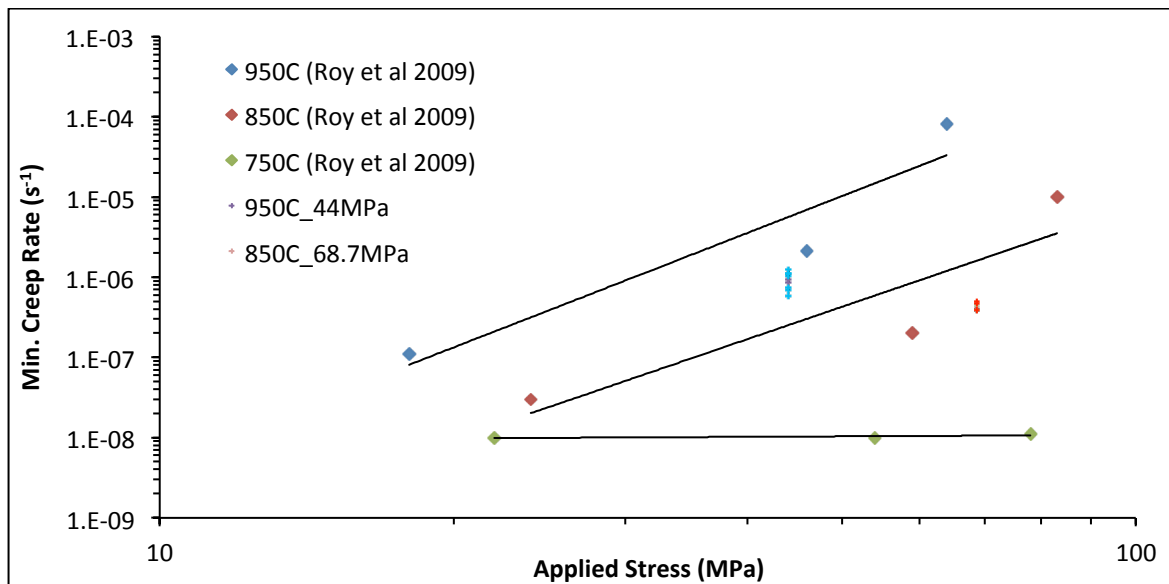
**Figure 2.1.2.12.** Constant creep rates compared with results from Roy et al 2009 [6]. All tests were conducted in an air environment.

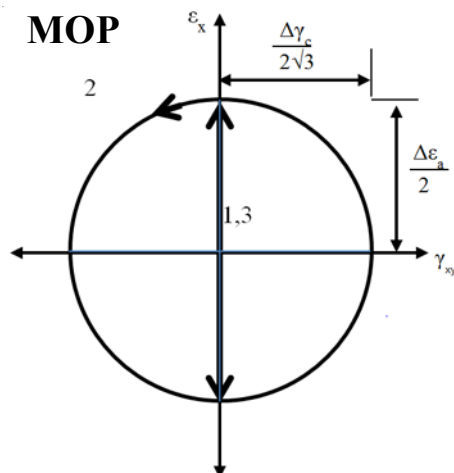
**MOP**

**MOP:** 100 axial strain cycles (I), followed by 100, 90° out-of-phase cycles (II), followed by 100 axial cycles (I).

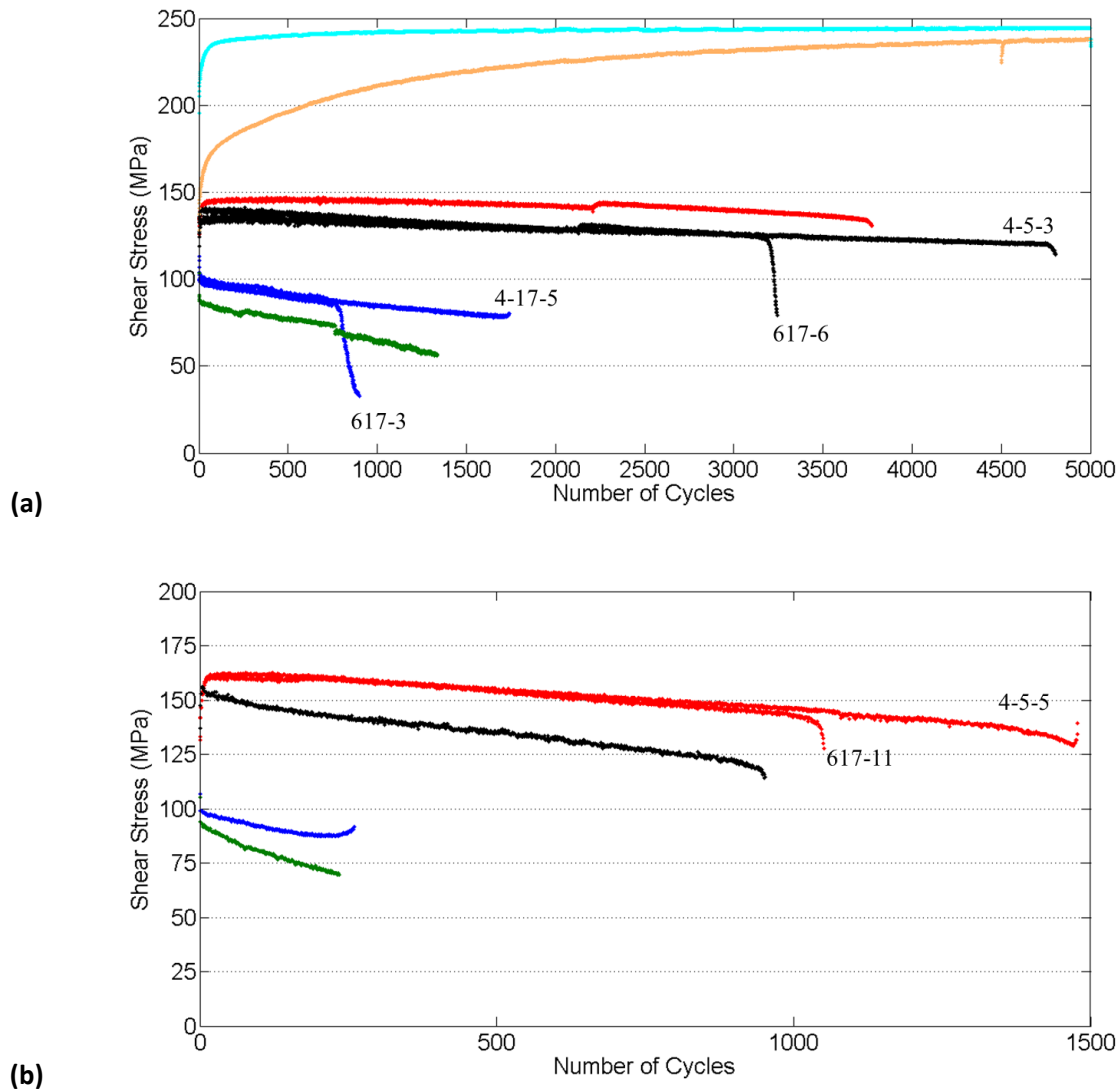
**Figure 2.1.3.2.** Effect of shear strain amplitude  $\Delta\gamma_c/(2\sqrt{3})$ ; (a) 0.002 rad and (b) 0.004 rad on cyclic shear stress peaks for MR1.

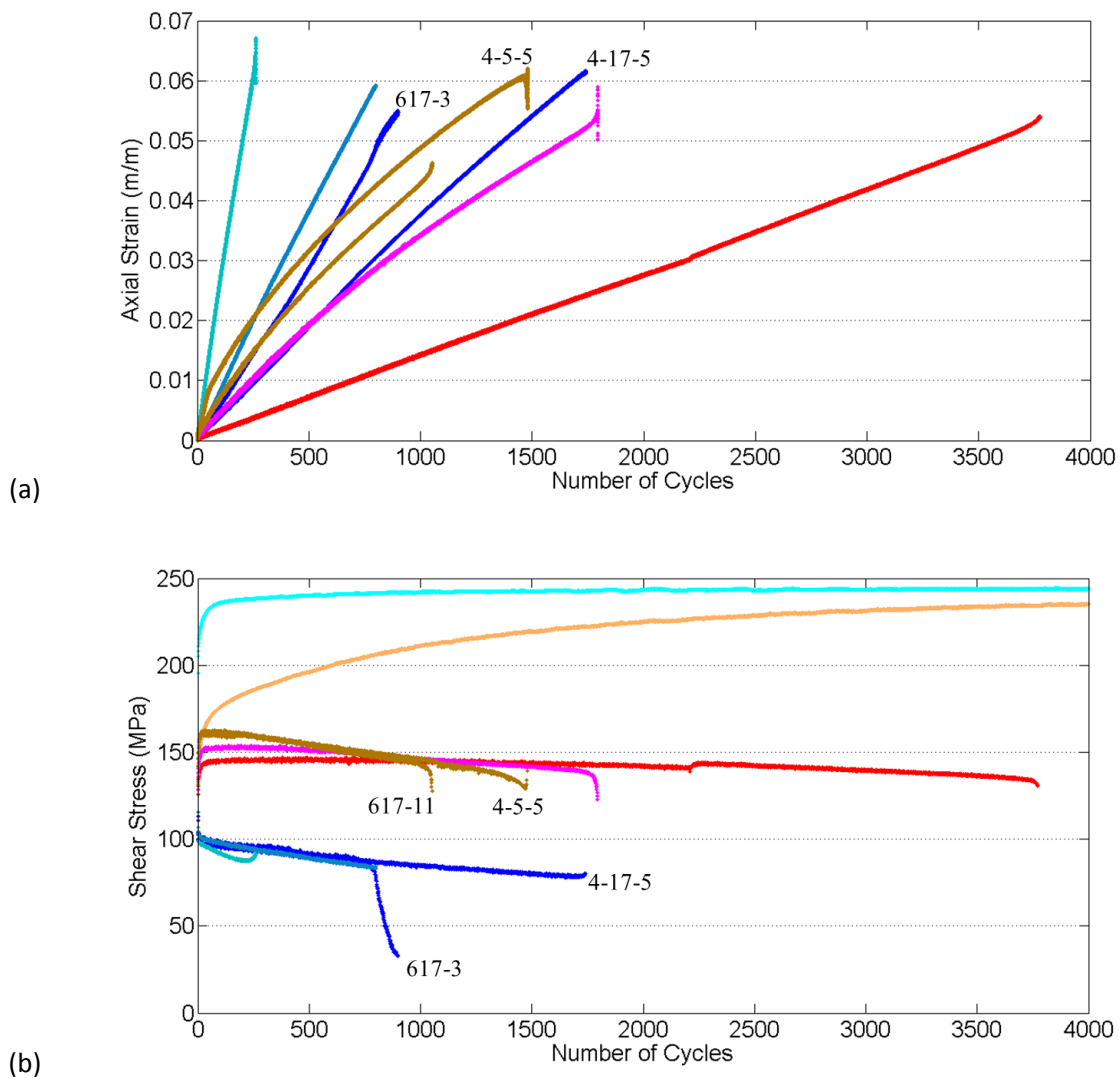
**Figure 2.1.3.3.** (a) Axial strain and (b) shear stress peaks for MR1 tests with fast loading rate of 0.10%/s. See Table 2.1.3.3 (b) for color legend.

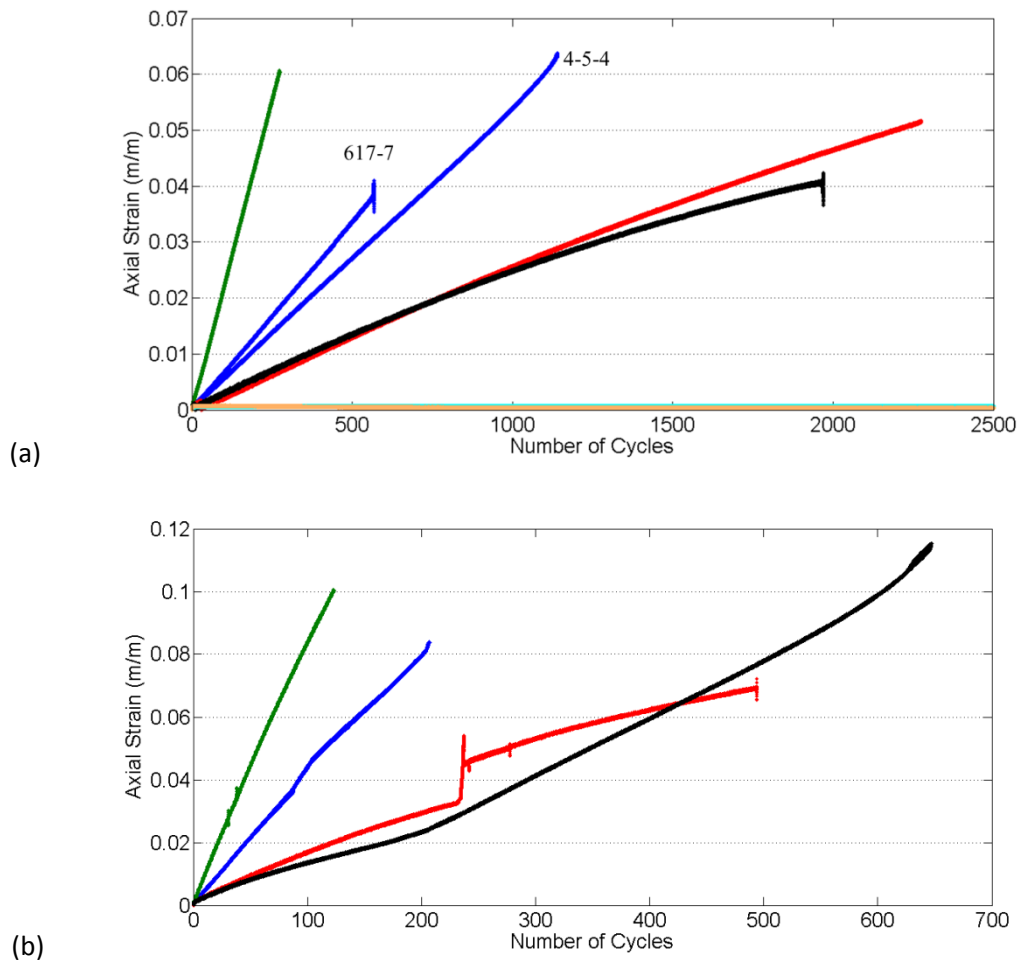
**Figure 2.1.3.4.** Axial strain for MR2 tests, where shear strain amplitude  $\Delta\gamma_c/(2\sqrt{3})$  was equivalent to (a) 0.0018 rad and (b) 0.004 rad.

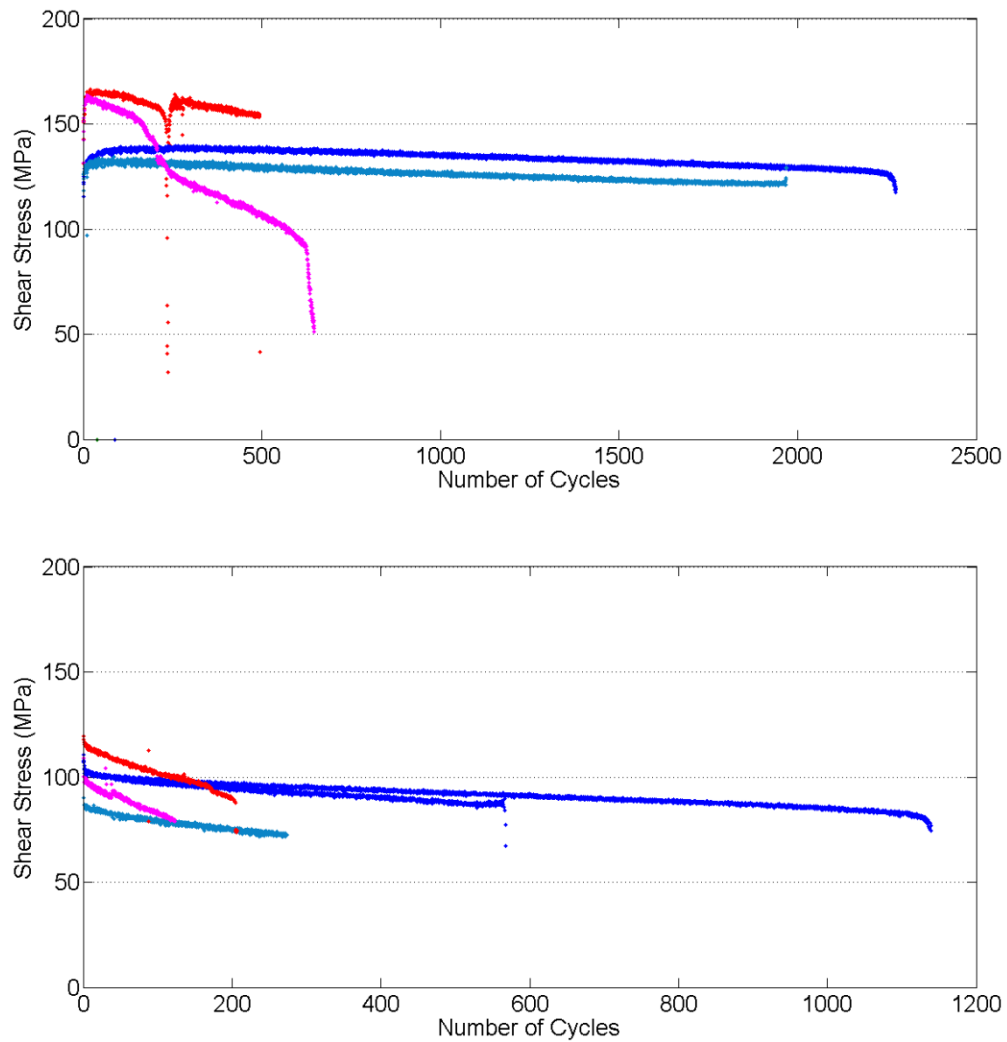
**Figure 2.1.3.7.** Peak values of the cyclic shear stress for MR2 tests (a) 850C and (b) 950C. See Table 2.1.3.5 (b) for color legend.

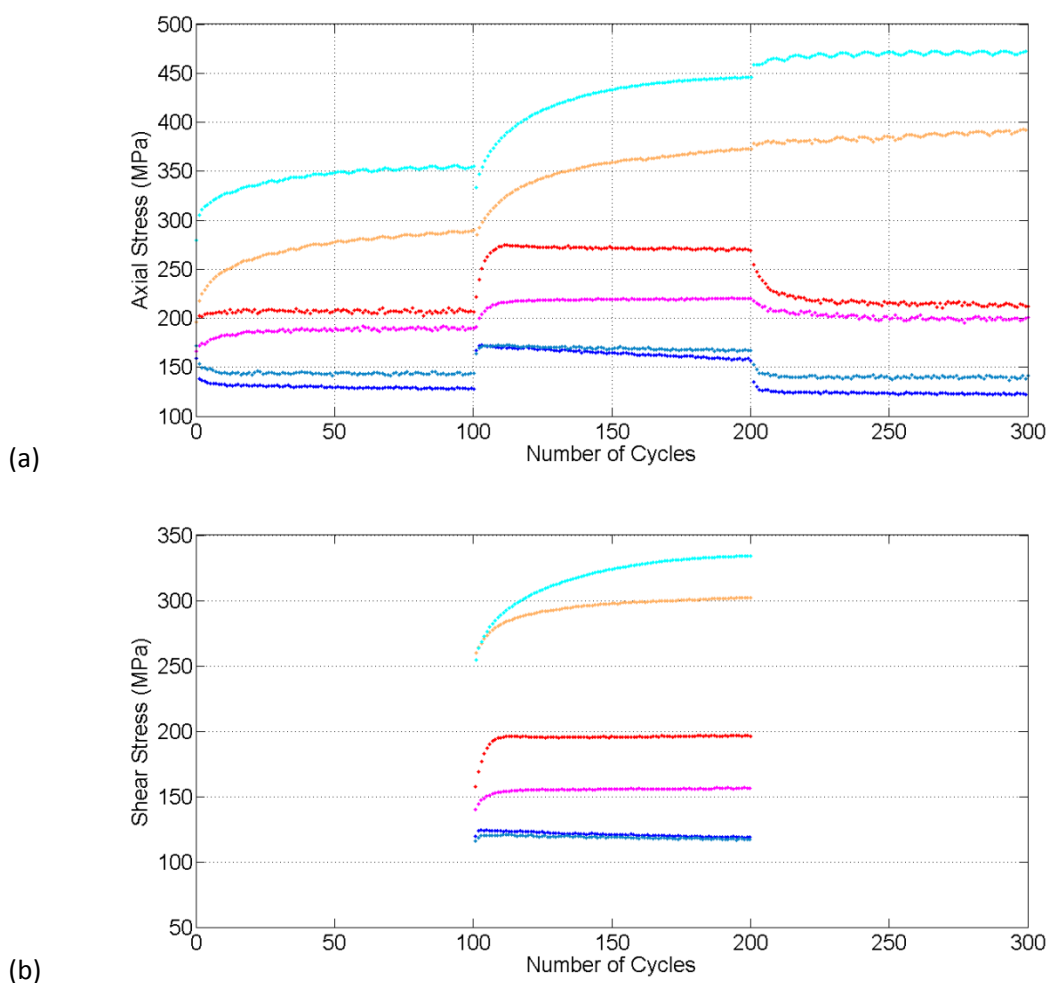
**Figure 2.1.3.10.** (a) Axial stress and (b) shear stress peaks for MOP tests with fast strain rate during Segments (1) and (3) [Tests 23, 25, 27, 29, 31, and 32]. See Table 2.1.3.7 (b) for color legend.

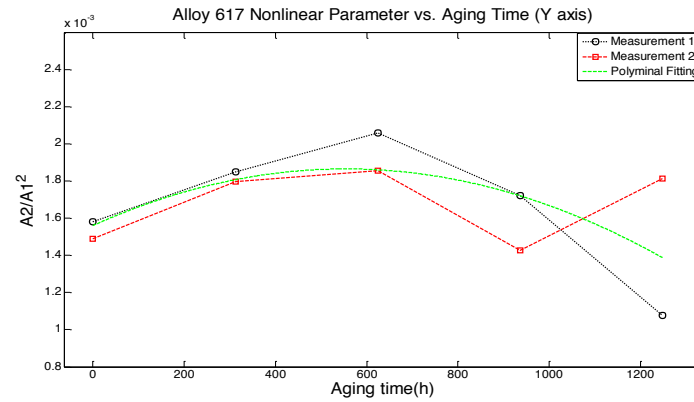
**Figure 2.2.1.4.** Alloy 617 nonlinear parameter versus exposure time in Y direction.

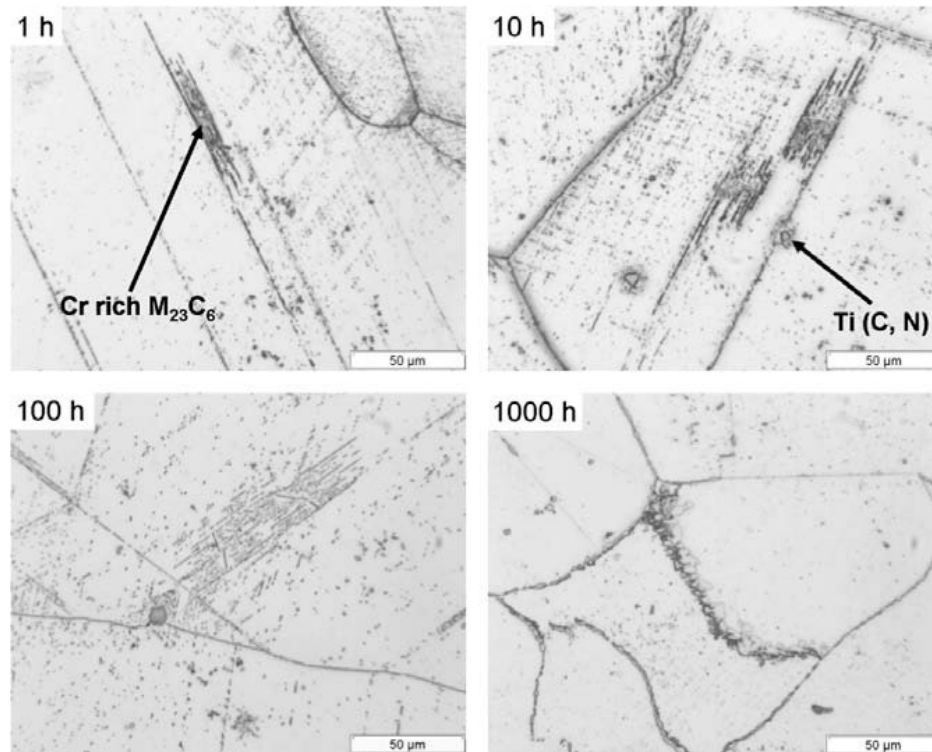
**Figure 2.2.1.7.** Alloy 617 microstructure evolution for thermal aging taken by Chomette et al. [3].

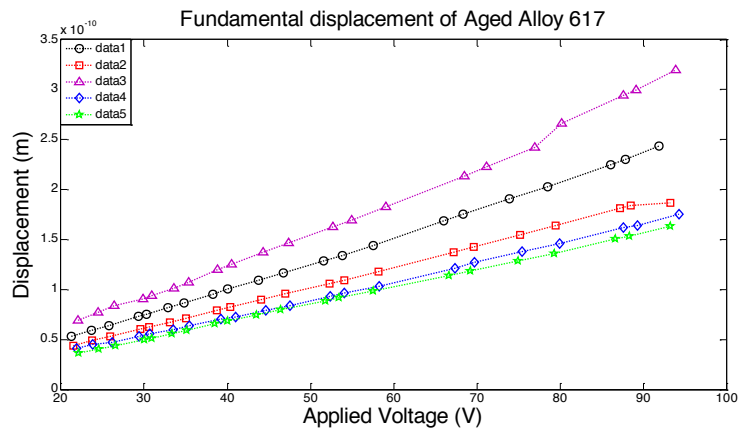
**Figure 2.2.1.8.** Fundamental displacements of aged Alloy 617 samples (15 cycles).

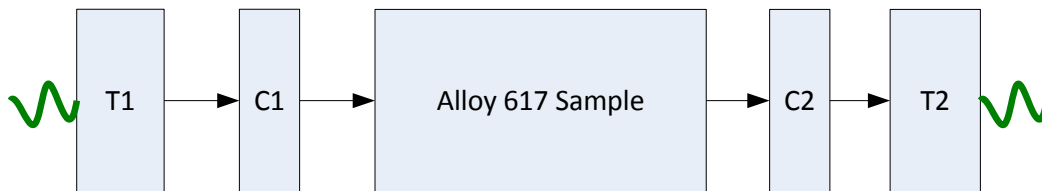
**Figure 2.2.1.14.** Schematic of nonlinearity measurement.

$$A_n(L) = \beta_n (A_1(0))^n f_n(\alpha_1, \alpha_2, \dots, \alpha_n, L) \quad (4)$$

where  $\beta_n$  is the nonlinear parameter and  $f_n(\alpha_1, \alpha_2, \dots, \alpha_n, L)$  is the factor that accounts for the attenuation at different harmonics.

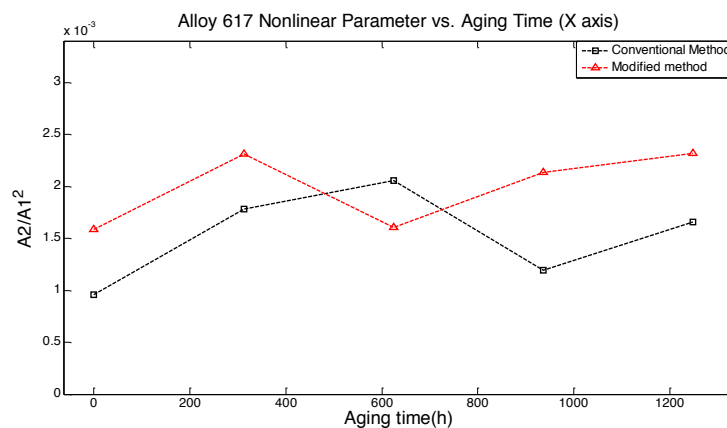
**Figure 2.2.1.17.** Alloy 617 nonlinear parameter as a function of exposure time for X direction (comparison between conventional method and modified method).

Figure 2.2.1.17 shows the qualitative nonlinear parameter of the aged samples by the conventional and modified methods. Experimental results from these two methods show good consistency. However, if we examine the standard error of the results for the two measurement methods shown in Table 2.2.1.2 we find that the standard error for the modified measurement method is much smaller than that from the conventional method. Which means the modified measurement can give us a more converged and accurate qualitative nonlinear parameter.

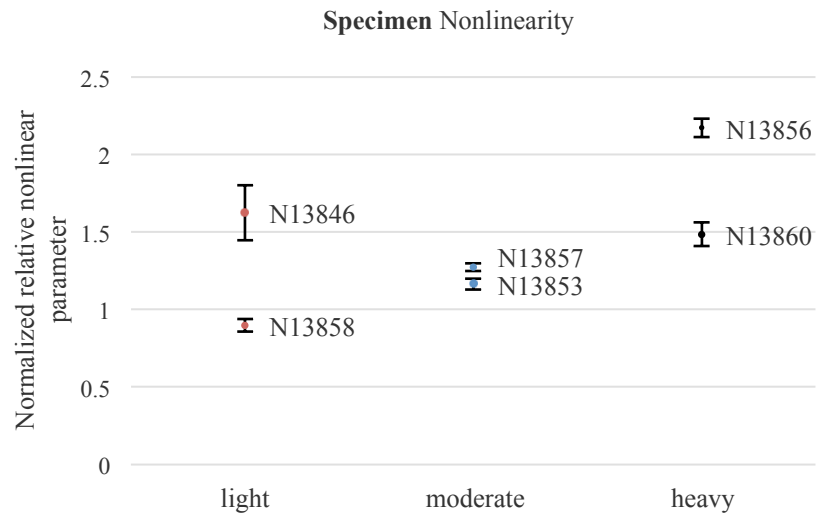
**Figure 2.2.1.22.** Normalized relative nonlinear parameter results for six different fatigued specimens, which sustained surface damage deemed to be: light (N13846, N13858), moderate (N13857, N13853), heavy (N13856, N13860). Error bars illustrate the standard deviation for three individual tests.

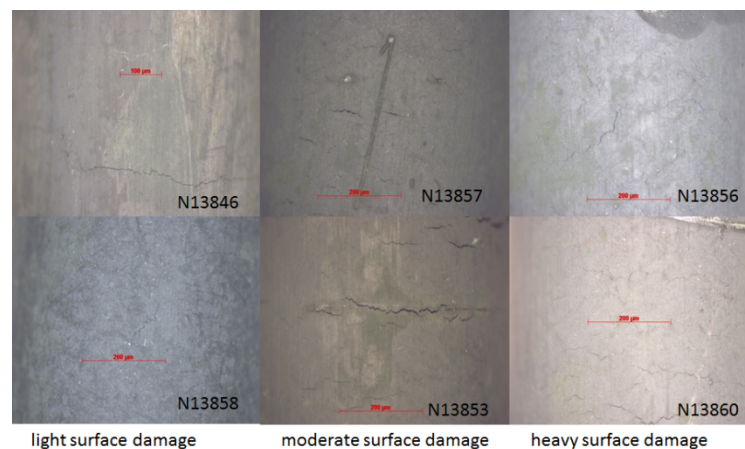
**Figure 2.2.1.23.** Stereoscope images of six fatigued specimens showing surface damage (25X magnification).

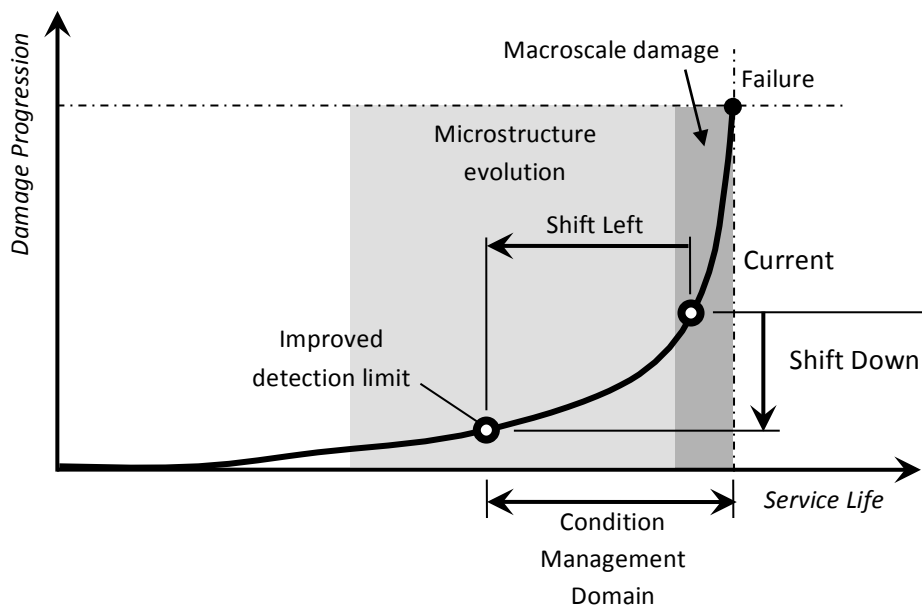
**Figure 2.2.2.1.** Shift to the left. As the minimum detectable damage shifts to the left relative to the service life the condition management domain increases.

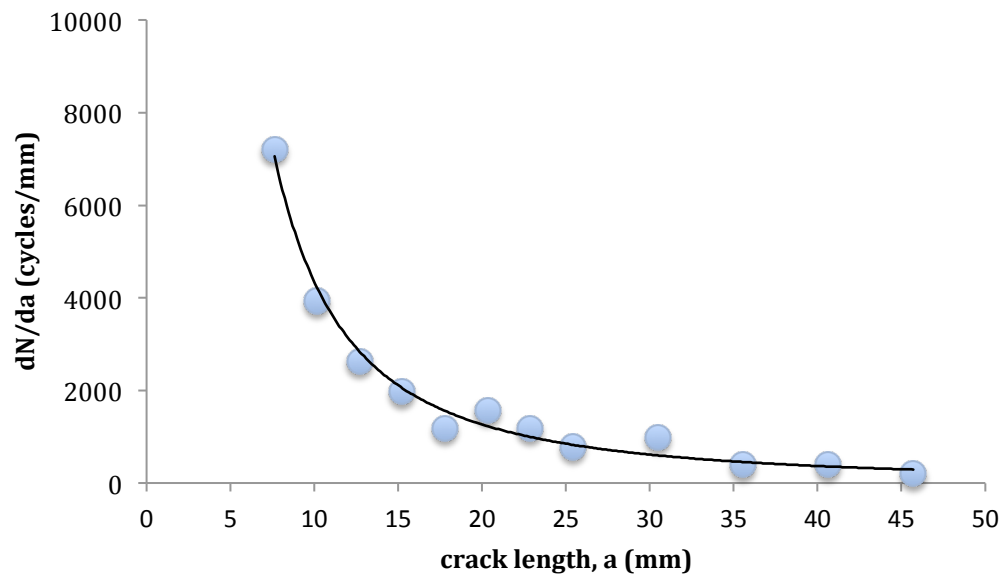
**Figure 2.2.2.2.** Cycles to grow crack  $a$  unit amount. Data for macrocrack growth in 7075-T6 aluminium for stress intensity ranges of  $10\text{--}27 \text{ MPa}\cdot\text{m}^{1/2}$ .

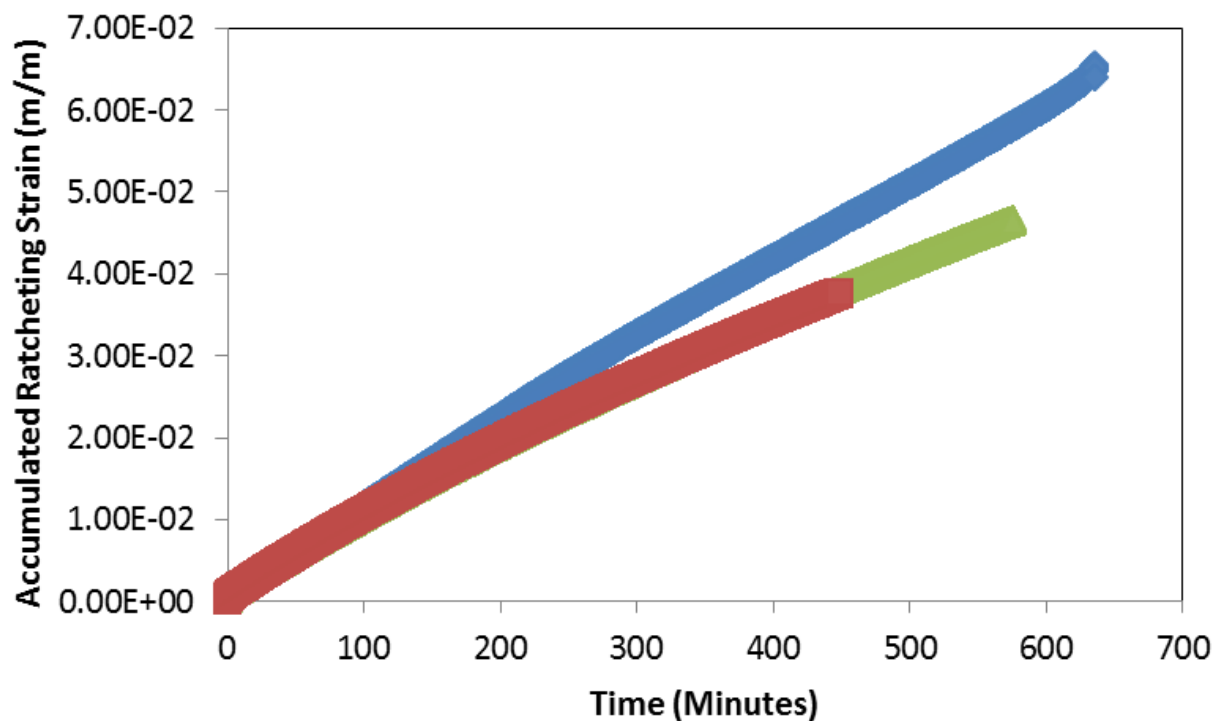
**Figure 2.2.2.9.** Accumulated axial ratcheting strain as a function of time for specimen 4-5-1 (Blue) and following tests interrupted at 71% and 58% of the accumulated (ratcheted) axial strain to failure.

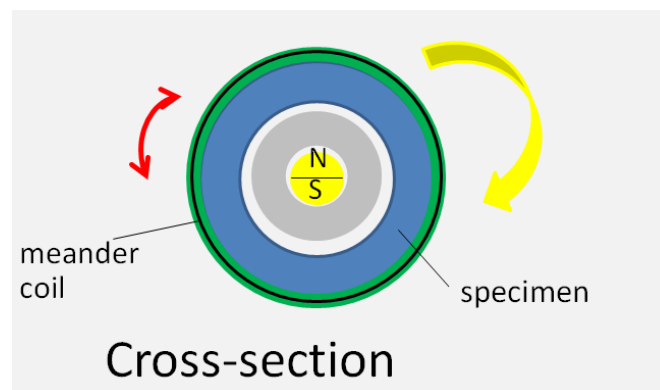
**Figure 2.2.2.10.** Schematic of experimental test setup for torsional mode  $T(0,1)$  in pipe.

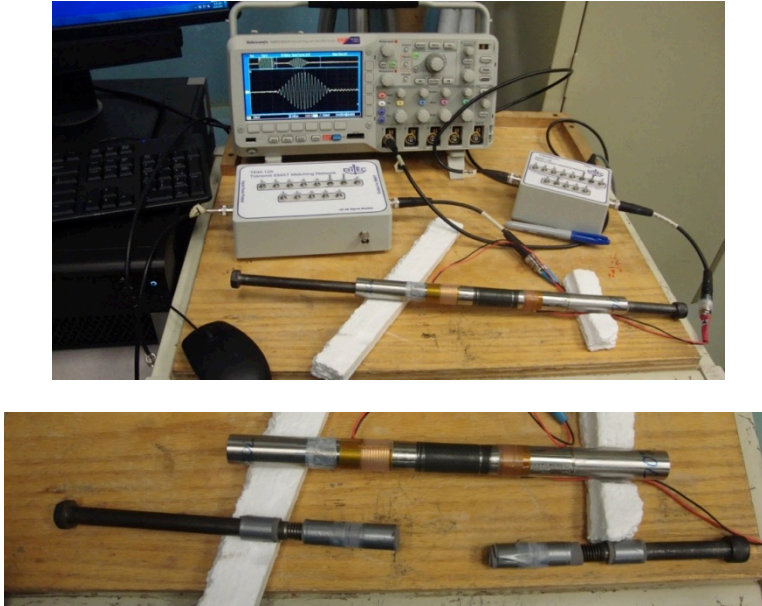
**Figure 2.2.2.13.** Each magnet was attached to a metal rod and placed so that it was within the pipe and generally concentric with the meander electric coils (orange).

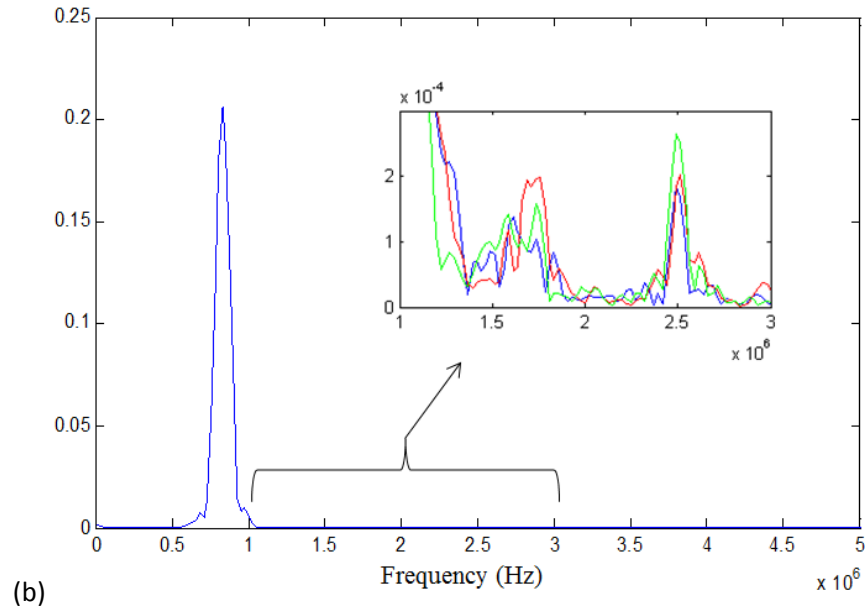
**Figure 2.2.2.15.** (a) A-scan, (b) frequency spectrum for  $T(0,1)$  mode excitation at 0.83 MHz.

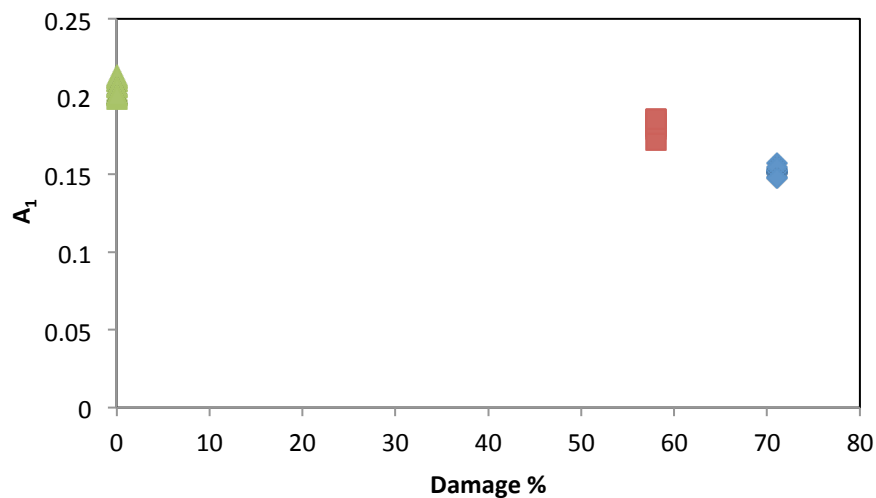
**Figure 2.2.2.16.** (a) Amplitude of primary mode  $T(0,1)$ , (b) amplitude of third harmonic, (c) normalized modal amplitude ratio (with respect to 0.0194).

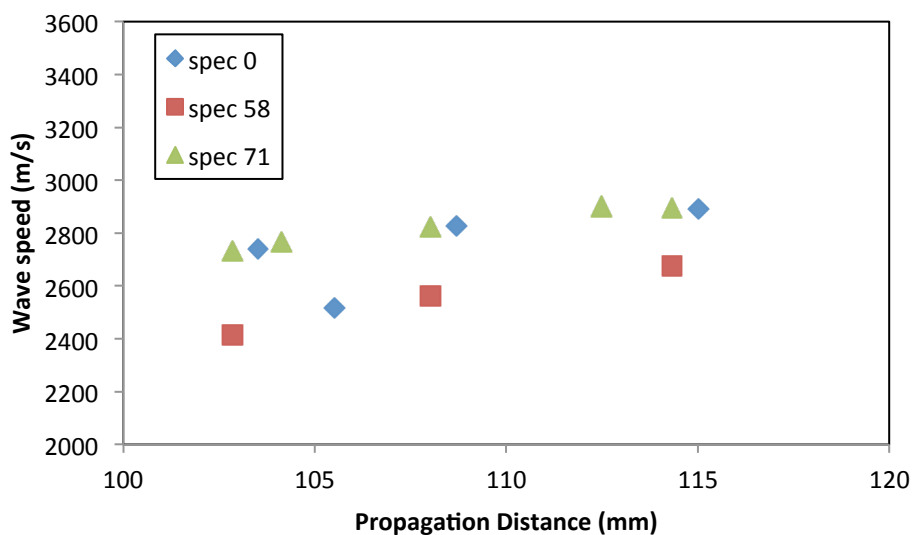
**Figure 2.2.2.17.** Wave speed measurements of T(0,1).

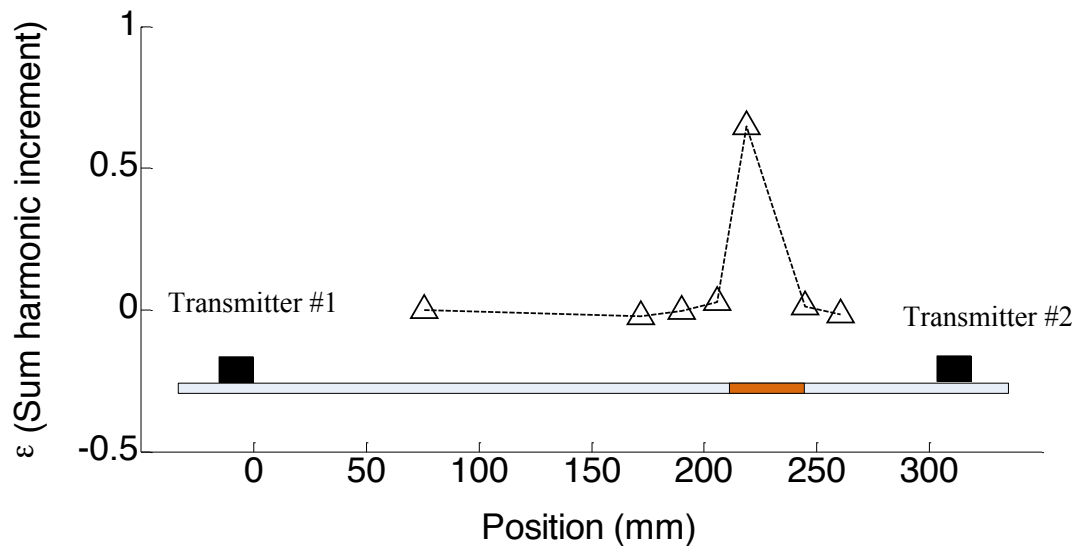
**Figure 2.2.2.22.** Sum harmonic incremental ratio for primary A0 and S1 mutual interaction generating internal resonant A1 mode. The scanning successfully identified localized material degradation.

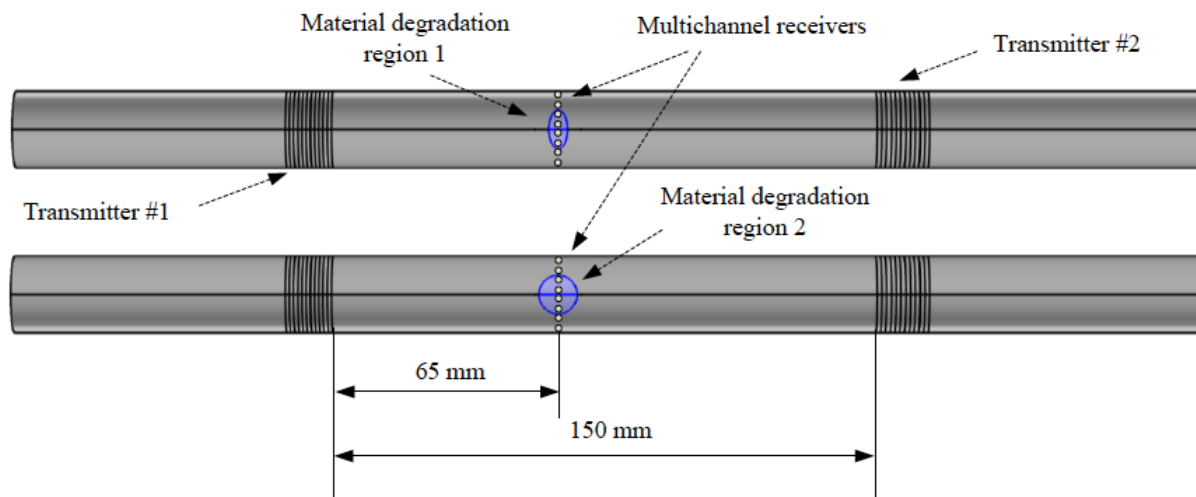
**Figure 2.2.2.26.** Schematic illustration of the nonlinear tomo-scanning conception. Two localized material degradation regions are introduced into the pipe. The material degradation is represent by increasing the third order elastic constants while keeping the linear elastic properties unchanged.

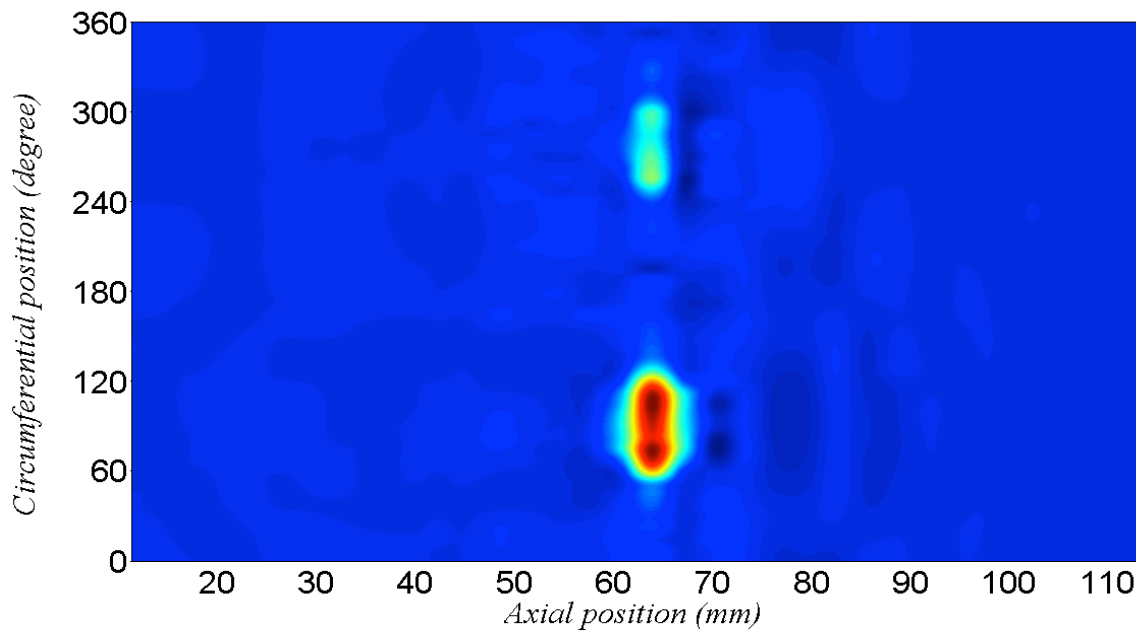
**Figure 2.2.2.29.** Tomogram of localized material degradation regions by the mode mutual interaction of two guided wave modes in a steel pipe.

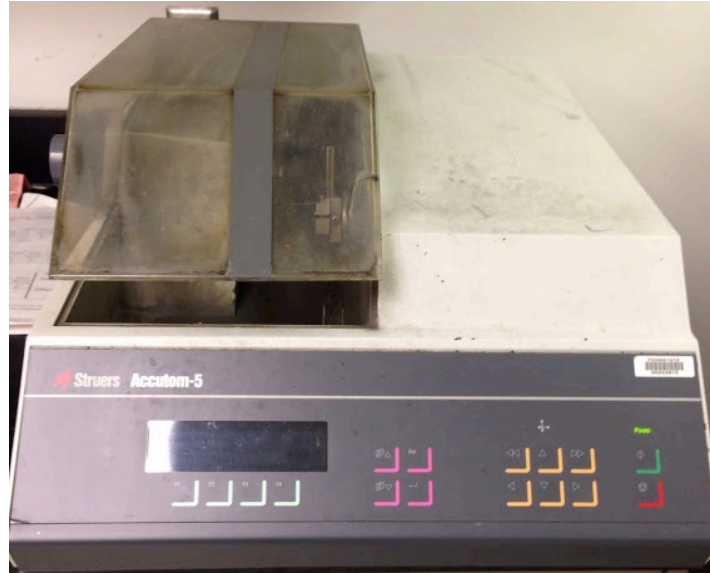
**Figure 2.3.1.1.** Struers Accutom-5 sample cut-off saw
